# **INDOOR AIR QUALITY ASSESSMENT**

**Bristol County 2<sup>nd</sup> District Court  
Fall River Court Complex  
45 Rock Street  
Fall River, Massachusetts**

Prepared by:  
Massachusetts Department of Public Health  
Bureau of Environmental Health Assessment  
October, 2000

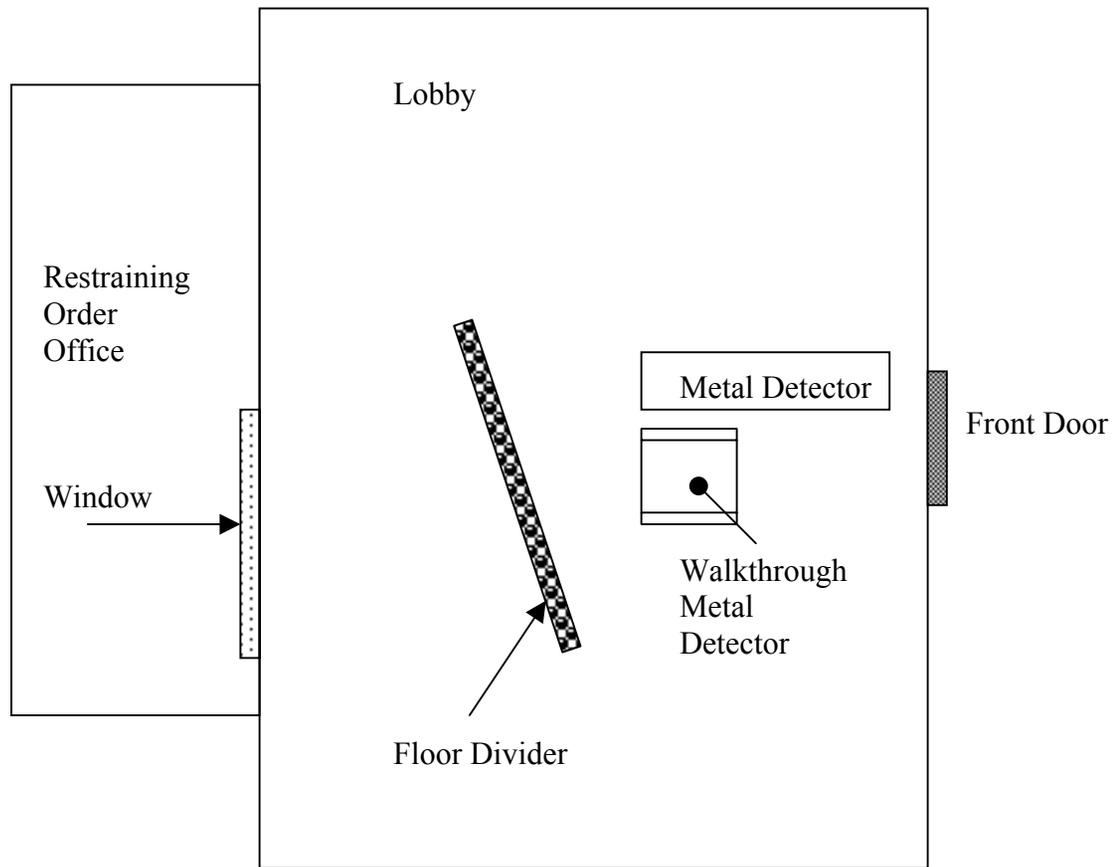
The restraining order office was reported as being prone to cold air drafts in cold weather. The front of these offices has a plexiglass window with several holes. This glass is located directly opposite the main entrance to the FRCC main entrance. With westerly winds in the winter, drafts of air entering the lobby would penetrate the restraining order office through the window holes. This condition would make temperature control difficult in the main lobby and restraining order office.

Proposed Placement of Floor Divider in Main Lobby to Direct Cold Air Away from Restraining Order Office

1. Examine the feasibility of providing local exhaust ventilation for the accounting and civil clerk's offices.
2. Examine the feasibility of installing floor dividers in the main lobby to limit cold air penetration (see Figure 1 for an example).
3. Examine the source of moisture that is damaging wall plaster in Court 1 and Court
5. Consider re-pointing exterior wall brick to prevent further wall damage.

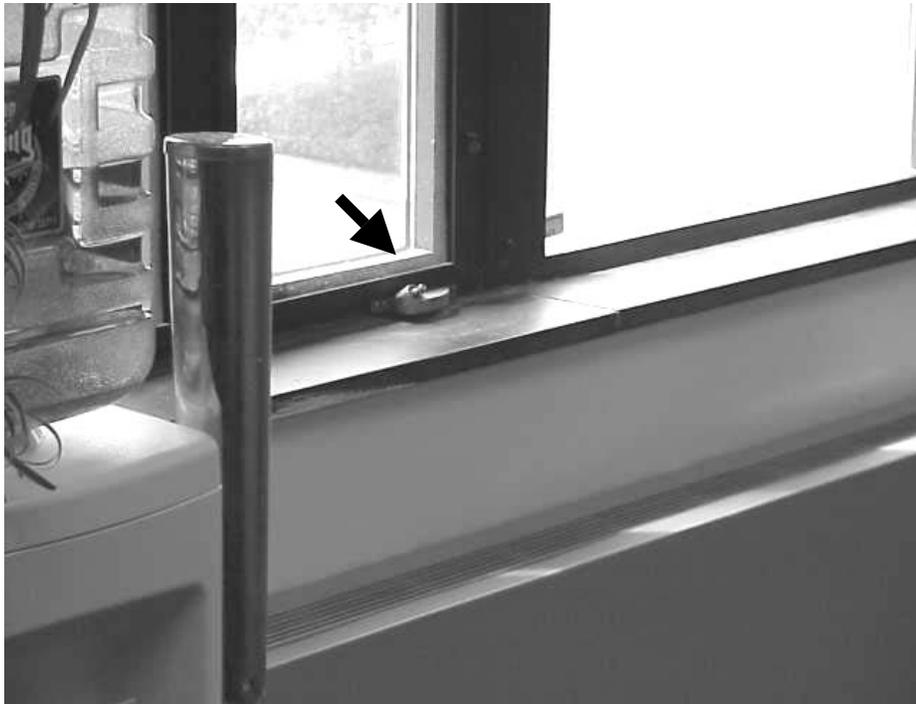
**Picture 3**

The old building is a two-story structure with an occupied basement. It contains courtroom 1, courtroom 5, small claims office, IT room, computer room, jury room, civil clerk's office, victim/witness desk, judge's lobbies, jury of six office and the original lock up which is now used for storage. The addition is a two story structure containing courts 2, 3, and 4, the probation offices, accounting, law library, jury deliberation rooms, judge's lobby, lock up, restraining order office and main lobby. Windows in the old building and in the addition can be opened, however a number of windows are missing cranks in the addition (see Picture 3).

**Window with Missing Crank Handle**

14. Replace missing window crank handles.
15. Change filters in window-mounted air conditioners as per the manufacturer's instructions to prevent the re-aerosolization of dirt, dust and particulate matter.
16. Repair damaged fiberglass insulation.

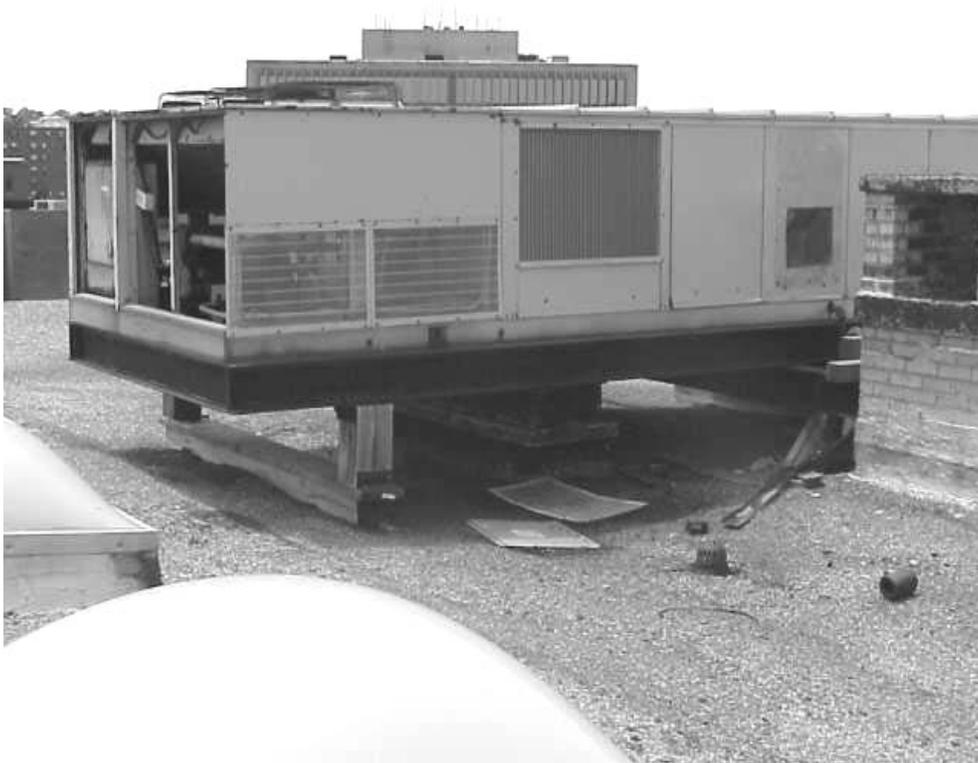
**Picture 4**

Fresh air is supplied in the old building by an air-handling unit (AHU) located on the roof (see Picture 4). It appears that ductwork and heat pumps were retrofitted into the old building, presumably during the construction of the addition. The fresh air intake of the AHU had its louvers set in the closed position, which limits the amount of fresh air drawn into the unit. With limitation of fresh air intake, the AHU recirculates air from occupied spaces in the old building. This condition can result in the accumulation of normally occurring indoor environmental pollutants, which can in turn cause indoor air quality related symptoms.

**AHU for Old Building**

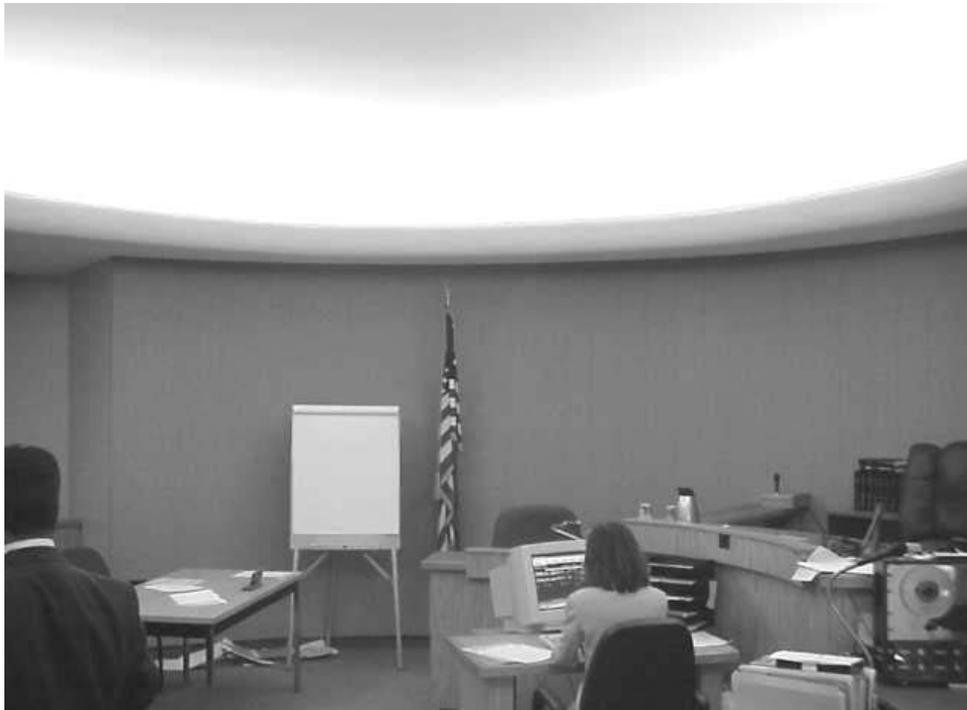
**Picture 5**

**Rotunda-like ceiling in Court 3**

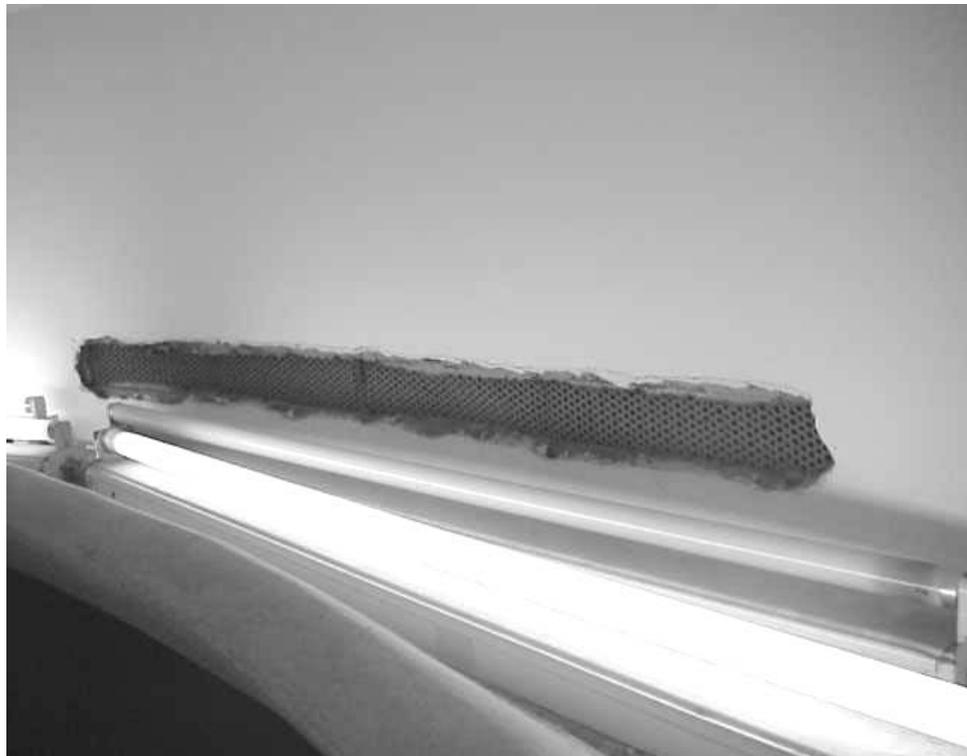
**Picture 6**

**Fresh Air Supply Vent over "Rotunda" Lip**

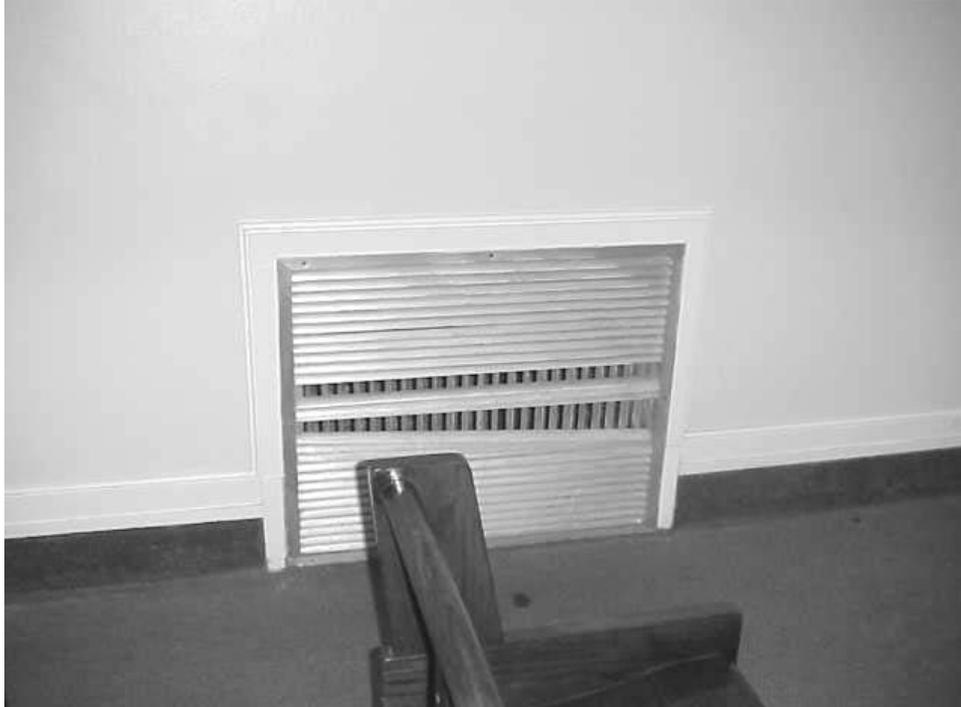
**Picture 7**

In order to have proper ventilation with a mechanical supply and exhaust system, the systems must be balanced to provide an adequate amount of fresh air to the interior of a room while removing stale air. Building employees reported that the ventilation system was balanced within the last year. Balancing of the ventilation system involves the analysis of the velocity of airflow [measured in cubic feet per minute (cfm)]. If this activity was done, the contractor should provide a ventilation balancing report detailing the air velocity measured for each vent examined. Once air velocity is measured, airflow can be increased or limited through the repositioning of louvers. In order to properly balance vents, it is recommended that the air velocity measured for a vent be +/- 10 percent of the design total designated by the architect (SMACNA, 1993). In order to balance the system, the ventilation contractor needs to obtain a copy of the building's blueprints in order to ascertain the total air velocity design for each vent. Whether this activity was done is doubtful since blueprints for the old building's ventilation system could not be located. The condition of the exhaust vent in court 1 also would render balancing difficult (see Picture 7). Damage to these louvers renders control of the airflow into this vent impossible.

**Damaged Louvers of Court 1 Exhaust Vent**

1. Replace the plastic grate in the accounting office with a solid ceiling tile.
2. Repair the louvers to the court 1 exhaust vent.
3. Operate all HVAC systems while the building is occupied. Set all thermostats in the “on” setting to operate the vent system during FRCC business hours.
4. Consult a ventilation engineer to maximize the operation of the HVAC system and repair if necessary the fresh air intake louvers in the old building AHU. Increase the amount of fresh air drawn by AHUs to increase comfort. Have the mechanical fresh air supply and exhaust balanced.

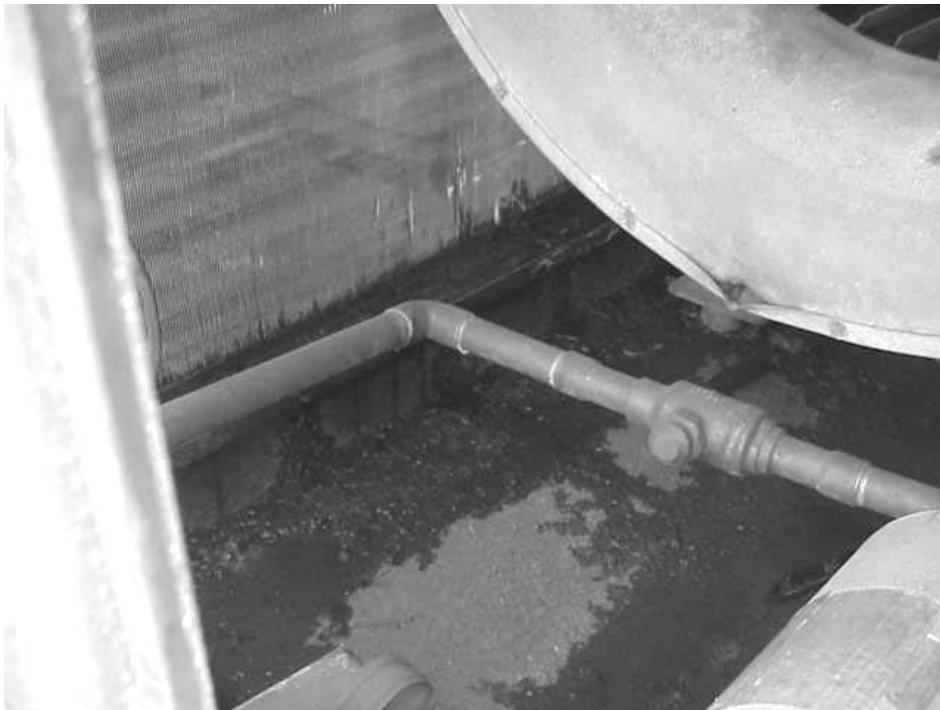
**Picture 8**

The interior of the old building AHU was evaluated during warm weather with the cooling coils activated. As outdoor air is drawn over cooling coils in the AHU, moisture in the form of condensation is generated. As condensation collects, water droplets are formed which drip from the cooling coils. Condensation is collected in drip pans beneath the cooling coils. Drip pans direct collected water from the AHU onto the roof. Pooling water was noted in the AHU drip pan (see Picture 8). The surface of the drip pan is severely corroded and rust chips were noted floating on the surface of the pooled water. Water emptying from the drain pan pipe onto the roof appeared to be minimal, which is a possible sign of clogging. Standing water in drip pans can serve as a growth medium for mold. If mold growth occurs, spores and odors can be transported into the interior of the building via the HVAC system.

**Corrosion of Coil and Drain Pan in the Old Building AHU**

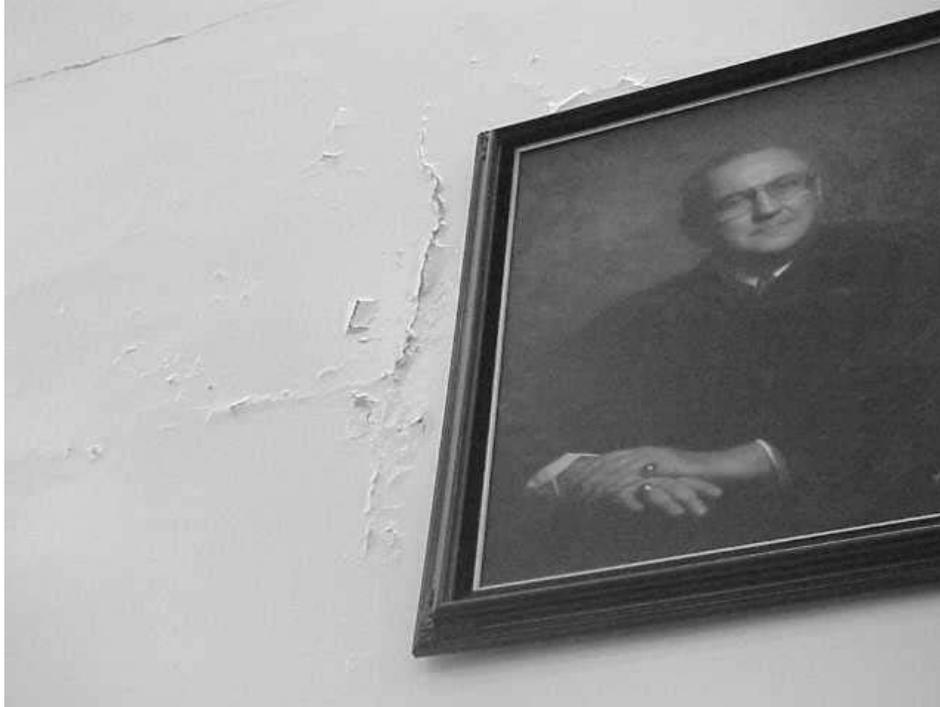
**Picture 9**

Court 1 (see Picture 9) and Court 5 had water damaged wall plaster. Water-damaged plaster can indicate that water is penetrating through exterior wall brickwork. Plaster can serve as a growth medium for mold if repeatedly moistened.

**Water Damaged Plaster in Court 1**

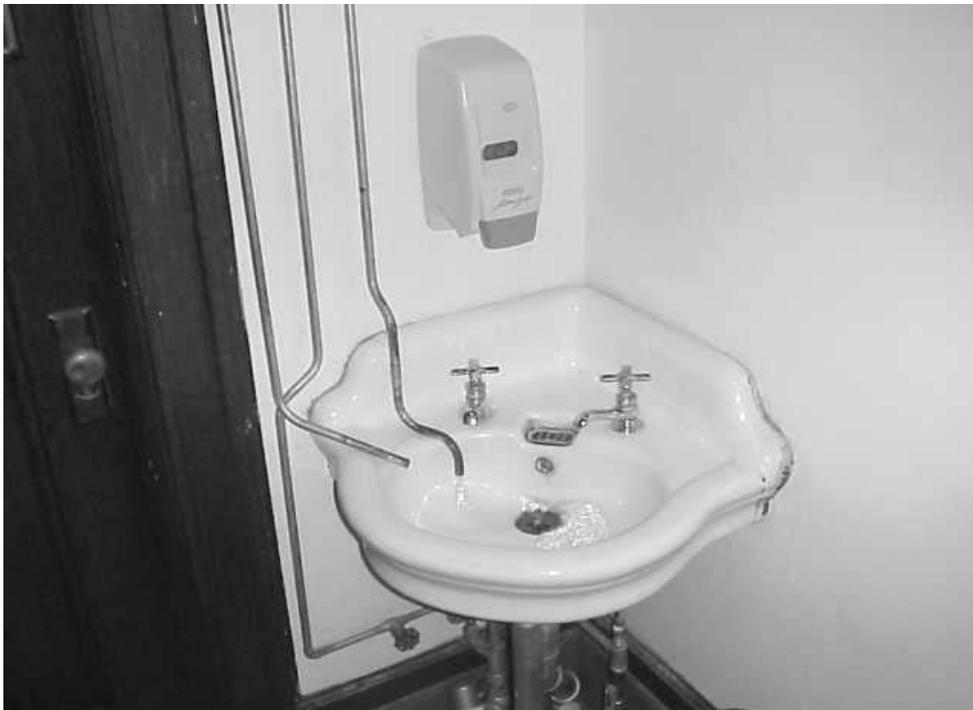
**Picture 10**

**Condensate Drain from Heat Pump in Civil Clerk's Office restroom Sink**

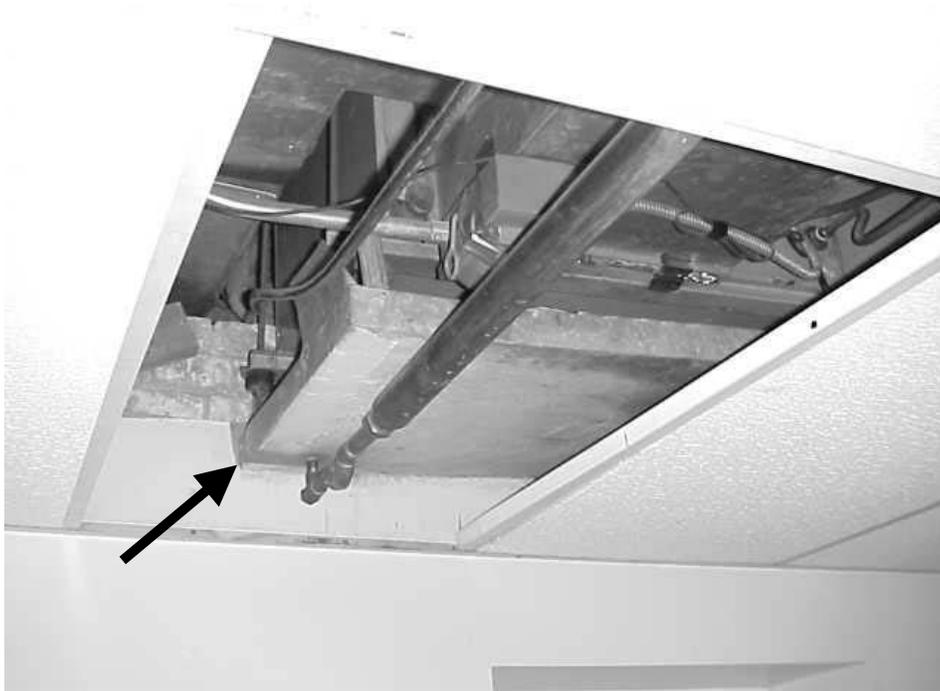
**Picture 11**

As noted previously, heat pumps were retrofitted into the old building to provide a mechanical ventilation system. These heat pumps provide both heating and cooling. Since these units can provide air-conditioning, provisions in each unit to drain condensation generated by the cooling coils must be made. In the civil clerk's office on the first floor, the contractor configured the condensation drain to empty into the sink of the restroom (see Picture 10). Above the ceiling at the victim/witness aid desk, a drip pan was installed below the heat pump to collect condensation from the exterior of the casing or pipe connections (see Picture 11). This condensation collection pan does not have a drain. Condensation collects in one end of the pan and eventually evaporates. Heavy

**Drain Pan beneath Heat Pump in Victim/Witness Desk Area**

9. Examine heat pipes for drains. If missing, consider installing drains to prevent water pooling and subsequent mold growth.
10. Consider placing water coolers on plastic/rubber floor mats to limit water damage to carpeting.

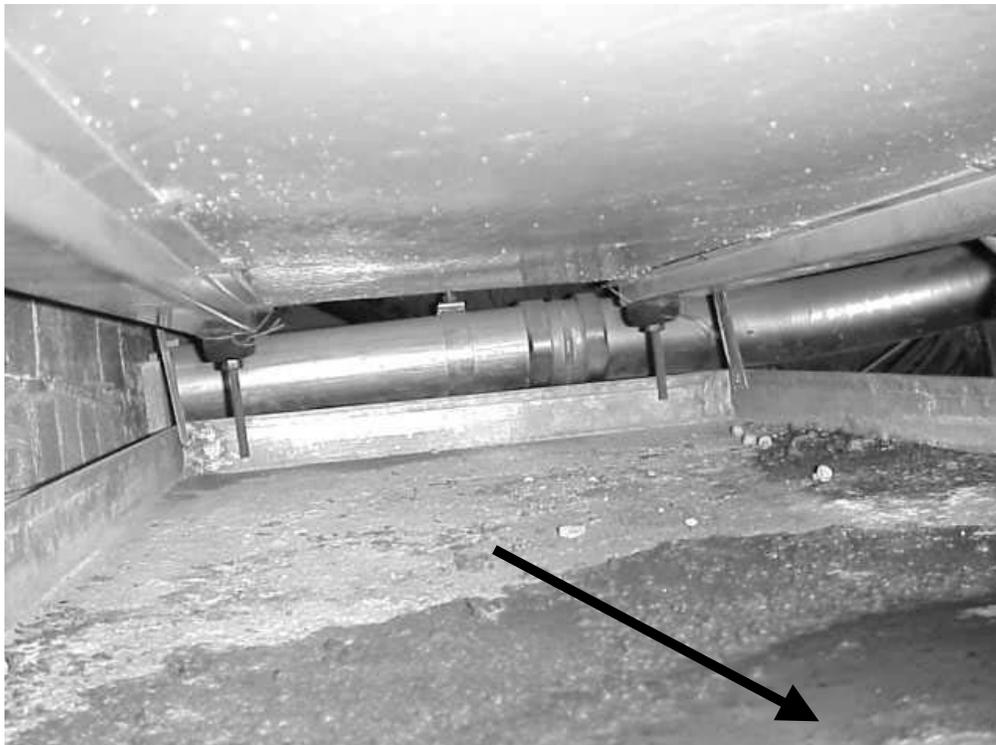
**Picture 12**

rust was noted at one end of this pan (see Picture 12), which indicates that this collection pan may have had standing water within it for substantial periods of time. Standing water can be a mold growth medium, resulting in musty/unpleasant odors.

**Corrosion in Drain Pan beneath Heat Pump in Victim/Witness Desk Area**

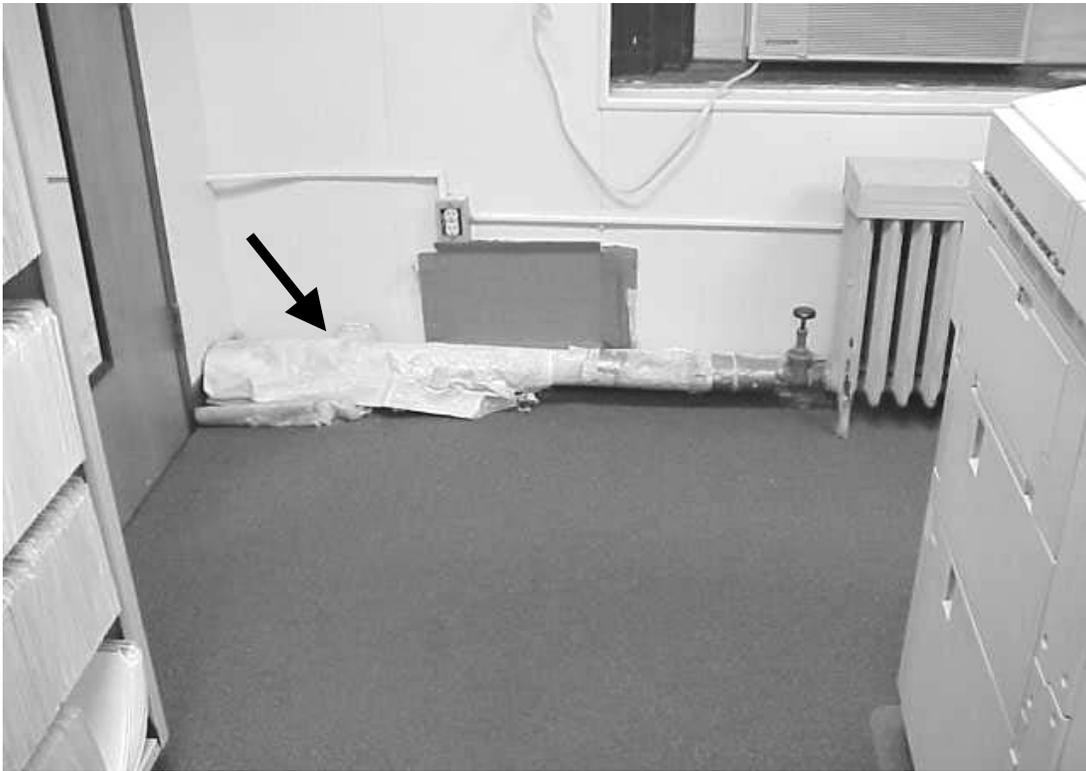
**Picture 13**

Damaged fiberglass insulation was noted in offices on the second floor of the old building (see Picture 13). Fiberglass insulation can be a source of skin, eye and respiratory irritation to sensitive individuals. The lock up in the old building could not be accessed during these assessments, but it is likely that the floors of these cells contain drains that would have dry traps. A dry drain trap can allow for sewer gas to back up into the old building basement area. Sewer gas can be irritating to the eyes, nose and throat. The elevator has an exhaust vent that does not appear to be functioning. Exhaust ventilation in elevator cars is necessary to remove unwanted odors from the interior.

**Damaged Fiberglass Pipe Insulation in the Small Claims Office**
